**Flood Control Project Maintenance  
Levee Inspections**  
**LMA District Cover Sheet**  
**Spring 2020 Levee Inspection Results**

**American River Flood Control District**

**Spring 2020 Levee Inspection Results**

Waterway			Bank	Unit Miles
Unit No. 01 Arcade Creek			Left	2.08
	Spring (March - May)	Summer (June - August)	(September - November) Fall	Winter (December - February)
Unit Maintenance Rating (Fall Only)				
Date of Inspection	3/25/2020 - 3/25/2020			
DWR Inspector	Luz Dial			
Accompanied By	Gilbert Gutierrez ARFCD

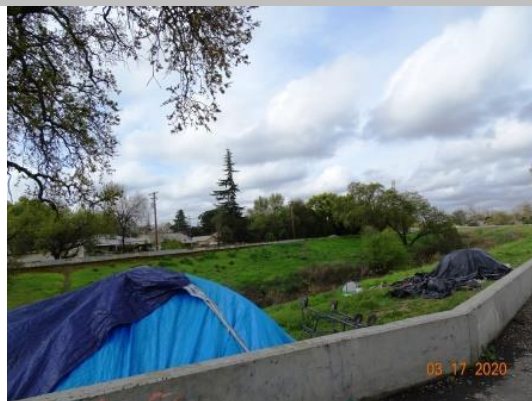
Photo 1 of 1 : SP\_2020\_NA0001\_58\_35\_20200319\_00057.jpg

LM Start	1.92	Rating **	M	Issue No.	35
LM End	1.92	Issue Type +	En	Location *	WS
Category	Earthen Levee			GPS Latitude/Longitude	
				Start	End
Item	Encroachments			38.628487 °	38.628487 °
				-121.436120 °	38.628487 °
DWR ID	DWR_NA0001_07_s_2020_35				
Comment Code					
DE : Debris					
Inspector Comment					
Three tents have been set on the waterside slope.

View of tents on the waterside slope. Spring 2020

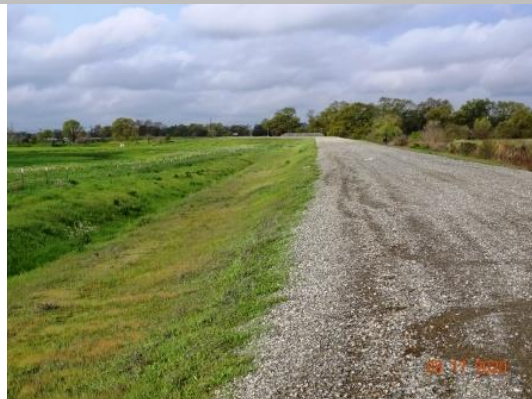
Photo 1 of 1 : SP\_2020\_NA0001\_59\_18\_20200319\_00018.jpg

LM Start	0.00	Rating **	A	Issue No.	18
LM End	0.26	Issue Type +	Ma	Location *	LS
Category	Earthen Levee			GPS Latitude/Longitude	
				Start	End
Item	Vegetation			38.667982 °	38.668305 °
				-121.447397 °	-121.442777 °
DWR ID	DWR_NA0001_08_s_2020_18				
Comment Code					
V1 : Control annual grass and weeds on the levee slopes and easements.					
Inspector Comment

View of well-maintained landside vegetation. Spring 2020

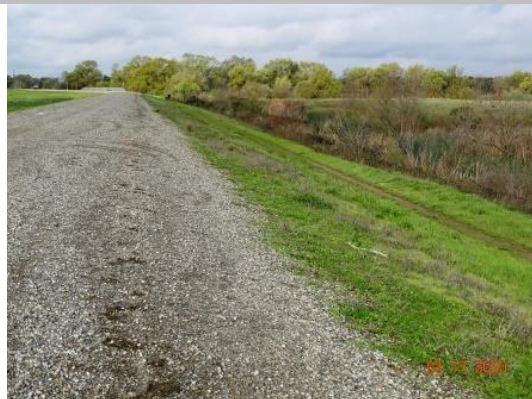
Photo 1 of 1 : SP\_2020\_NA0001\_59\_19\_20200319\_00019.jpg

LM Start	0.00	Rating **	A	Issue No.	19
LM End	0.26	Issue Type +	Ma	Location *	WS
Category	Earthen Levee			GPS Latitude/Longitude	
				Start	End
Item	Vegetation			38.667982 °	38.668305 °
				-121.447397 °	-121.442777 °
DWR ID	DWR_NA0001_08_s_2020_19				
Comment Code					
V1 : Control annual grass and weeds on the levee slopes and easements.					
Inspector Comment

View of well-maintained waterside vegetation. Spring 2020

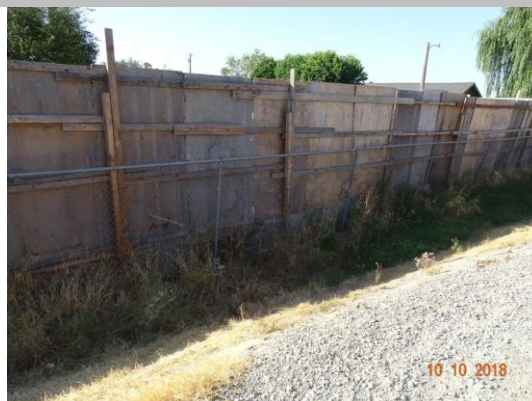
Photo 1 of 1 : SP\_2020\_NA0001\_59\_13\_20200302\_00008.jpg

LM Start	0.31	Rating **	U	Issue No.	13
LM End	0.32	Issue Type +	En	Location *	LS
Category	Earthen Levee			GPS Latitude/Longitude	
				Start	End
Item	Encroachments			38.668164 °	38.668152 °
				-121.441870 °	-121.441639 °
DWR ID	DWR_NA0001_08_f_2018_13				
Comment Code					
FE : Fence					
Inspector Comment					
A raised wooden fence blocks visibility along the levee easement.

View of raised wooden fence that blocks visibility along levee easement. Fall 2018

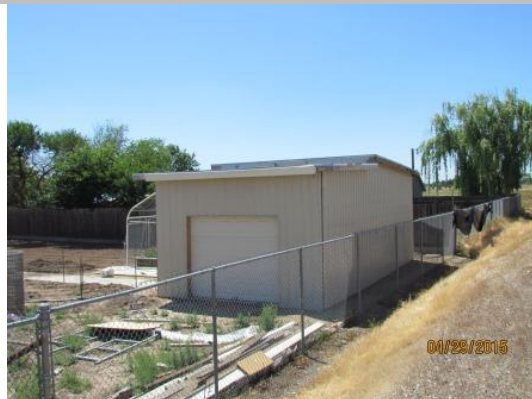
Photo 1 of 1 : SP\_2020\_NA0001\_59\_15\_20200302\_00010.jpg

LM Start	0.33	Rating **	U	Issue No.	15
LM End	0.33	Issue Type +	En	Location *	LS
Category	Earthen Levee			GPS Latitude/Longitude	
				Start	End
Item	Encroachments			38.668135 °	38.668135 °
				-121.441563 °	-121.441563 °
DWR ID	DWR_NA0001_08_f _ 2013_15				
Comment Code					
BU : Building					
Inspector Comment					
A building is located within 10 feet of the landside levee toe.

View of the building within 10 feet of landside levee toe, facing downstream. Spring 2015

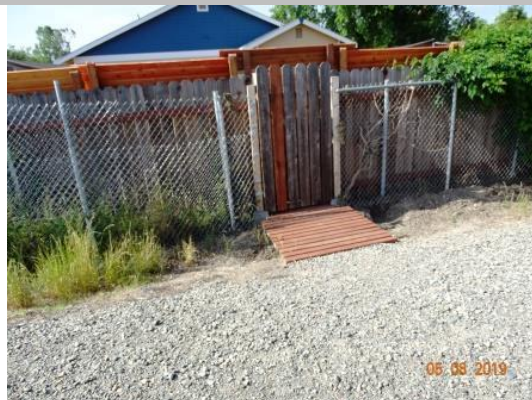
Photo 1 of 2 : SP\_2020\_NA0001\_59\_12\_20200302\_00006.jpg

LM Start	0.38	Rating **	U	Issue No.	12
LM End	0.38	Issue Type +	En	Location *	LS
Category	Earthen Levee			GPS Latitude/Longitude	
				Start	End
Item	Encroachments			38.668149 °	38.668147 °
				-121.440704 °	-121.440533 °
DWR ID	DWR_NA0001_08_f_2018_12				
Comment Code					
FE : Fence					
Inspector Comment					
A wooden fence with vegetation blocks visibility of levee easement. A wooden bridge was built to connect to the levee crown.

View of wooden ramp that connects gate to levee crown. Spring 2019

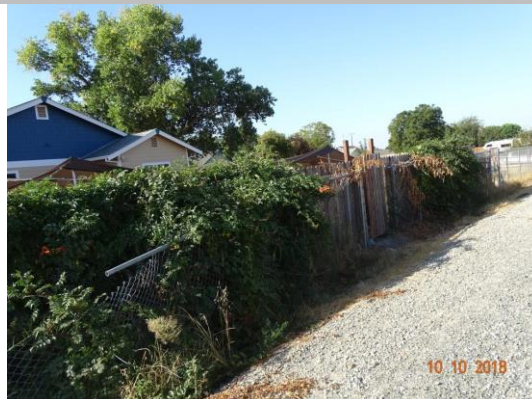
Photo 2 of 2 : SP\_2020\_NA0001\_59\_12\_20200302\_00007.jpg

LM Start	0.38	Rating **	U	Issue No.	12 (cont)
LM End	0.38	Issue Type +	En	Location *	LS
Category	Earthen Levee			GPS Latitude/Longitude	
				Start	End
Item	Encroachments			38.668149 °	38.668147 °
				-121.440704 °	-121.440533 °
DWR ID	DWR_NA0001_08 f _ 2018_12

View of wooden fence with vegetation that blocks visibility of levee easement. Fall 2018

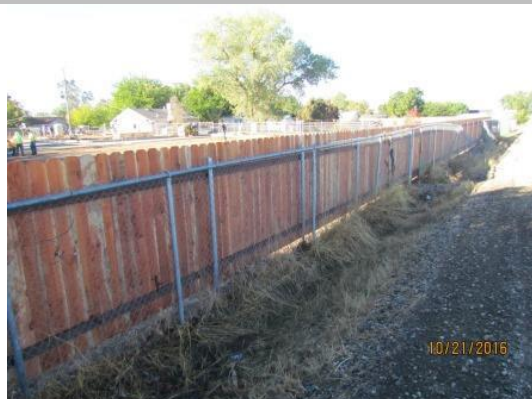
Photo 1 of 1 : SP\_2020\_NA0001\_59\_22\_20200302\_00012.jpg

LM Start	0.39	Rating **	U	Issue No.	22
LM End	0.40	Issue Type +	En	Location *	LS
Category	Earthen Levee			GPS Latitude/Longitude	
				Start	End
Item	Encroachments			38.668145 °	38.668118 °
				-121.440493 °	-121.440268 °
DWR ID	DWR_NA0001_08_s_2014_22				
Comment Code					
FE : Fence					
Inspector Comment					
Fence appears to be constructed at the property line. Fence limits visibility of the landside easement.

View of the wooden fence at the landside levee toe. Fall 2016

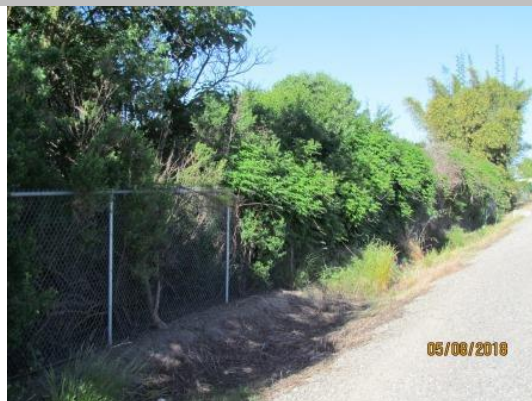
Photo 1 of 1 : SP\_2020\_NA0001\_59\_6\_20200302\_00003.jpg

LM Start	0.40	Rating **	U	Issue No.	6
LM End	0.43	Issue Type +	En	Location *	LS
Category	Earthen Levee			GPS Latitude/Longitude	
				Start	End
Item	Vegetation			38.668147 °	38.668141 °
				-121.440248 °	-121.439755 °
DWR ID	DWR_NA0001_08_s_2012_6				
Comment Code					
V6 : Landscaping					
Inspector Comment					
Vines on fence limit visibility.

View of the vines on fence obstructing visibility of landside toe. Spring 2018

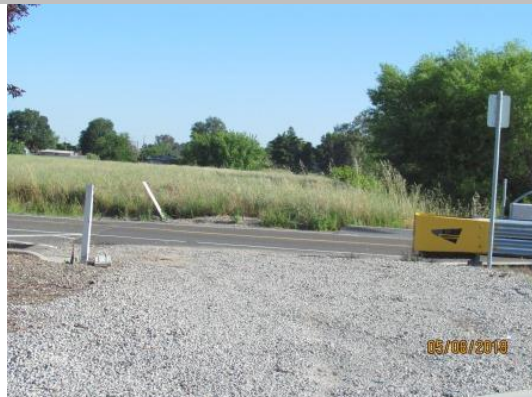
Photo 1 of 1 : SP\_2020\_NA0001\_59\_1\_20200302\_00001.jpg

LM Start	0.51	Rating **	A/W	Issue No.	1
LM End	1.03	Issue Type +	En	Location *	WS
Category	Earthen Levee			GPS Latitude/Longitude	
				Start	End
Item	Encroachments			38.668132 °	38.665528 °
				-121.438229 °	-121.431688 °
DWR ID	DWR_NA0001_08_s_2012_1				
Comment Code					
MA : Material					
Inspector Comment					
This portion is channel only, and there is no access for maintenance.

View looking downstream at inaccessible portion of Magpie Creek.  
There is only channel maintenance in this section.

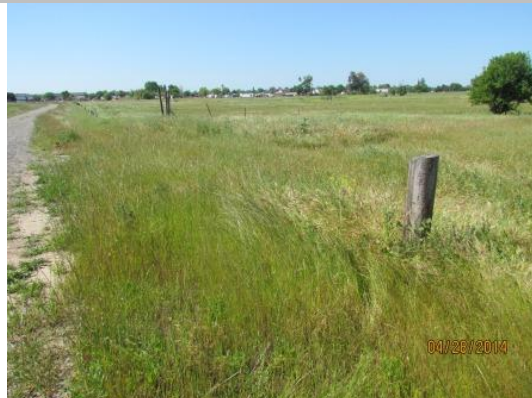
Photo 1 of 1 : SP\_2020\_NA0001\_59\_20\_20200302\_00011.jpg

LM Start	1.22	Rating **	M	Issue No.	20
LM End	1.22	Issue Type +	En	Location *	LS
Category	Earthen Levee			GPS Latitude/Longitude	
				Start	End
Item	Encroachments			38.662816 °	38.662816 °
				-121.431678 °	-121.431678 °
DWR ID	DWR_NA0001_08_s_2014_20				
Comment Code					
PO : Pole					
Inspector Comment

View of the pole on landside levee toe. Spring 2014

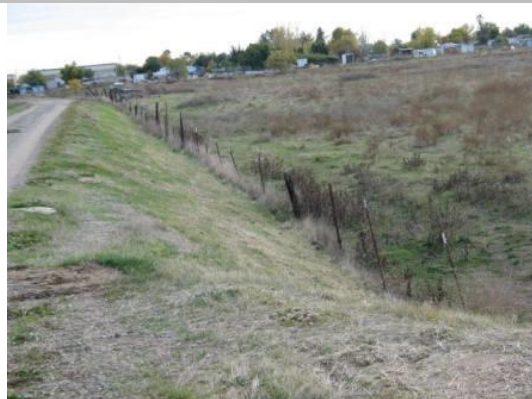
Photo 1 of 1 : SP\_2020\_NA0001\_59\_2\_20200302\_00002.jpg

LM Start	1.22	Rating **	M	Issue No.	2
LM End	1.31	Issue Type +	En	Location *	LS
Category	Earthen Levee			GPS Latitude/Longitude	
				Start	End
Item	Encroachments			38.662715 °	38.661584 °
				-121.431666 °	-121.431402 °
DWR ID	DWR_NA0001_08_s_2012_2				
Comment Code					
FE : Fence					
Inspector Comment					
Barbed wire fence runs along the levee toe.

11/17/2011 Barbed wire fence at levee toe.

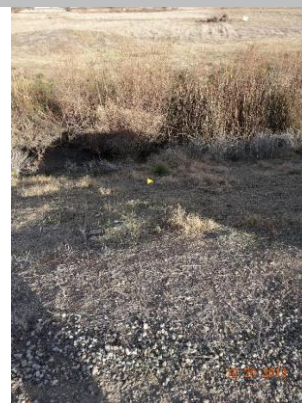
Photo 1 of 2 : UCIP\_SP\_2020\_30689\_56509.jpg

LM Start	1.28	Rating **	M	Issue No.	23
LM End	1.28	Issue Type +	En	Location *	
Category	Supplemental			GPS Latitude/Longitude	
				Start	End
Item	DWR UCIP Field Study			38.661843 °	38.661843 °
				-121.431675 °	-121.431675 °
DWR ID	24815				
Comment Code					
Inspector Comment					
DS_ID:24815 FS_ID:30689 EP_NO: N/A Repair Type: Non-Urgent Crossing Status: Indicator Found UCIP Comments: unable to confirm if conduit or gas line cross levee or flag identifying problem areas. Need additional information. FIELD_STRUCT_DESC: Underground service alert (USA) markers found on waterside (WS) and landside (LS) during field inspection. FS Date: 12/20/2013

View of waterward side.

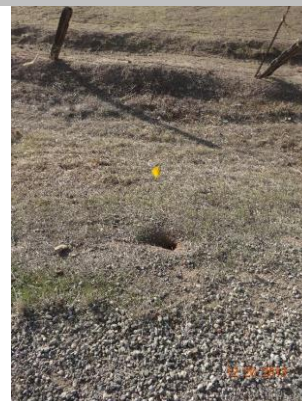
Photo 2 of 2 : UCIP\_SP\_2020\_30689\_56508.jpg

LM Start	<b>1.28</b>	Rating **	M	Issue No.	<b>23 (cont)</b>
LM End	<b>1.28</b>	Issue Type +	En	Location *	
Category	Supplemental		GPS Latitude/Longitude		
			Start	End	
Item	DWR UCIP Field Study		38.661843 °	38.661843 °	
			-121.431675 °	-121.431675 °	
DWR ID	24815

View of landward side.

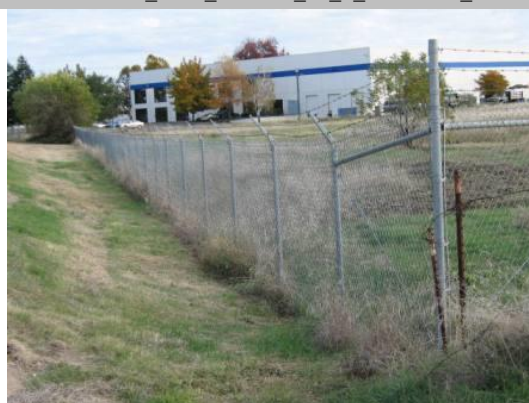
Photo 1 of 1 : SP\_2020\_NA0001\_59\_7\_20200302\_00004.jpg

LM Start	1.30	Rating **	M	Issue No.	7
LM End	1.33	Issue Type +	En	Location *	LS
Category	Earthen Levee			GPS Latitude/Longitude	
				Start	End
Item	Encroachments			38.661593 °	38.661370 °
				-121.431420 °	-121.430943 °
DWR ID	DWR_NA0001_08_s_2012_7				
Comment Code					
FE : Fence					
Inspector Comment					
Cyclone fence with barbed wire is within 10' of toe for part of its alignment.

11/17/2011 Chainlink fence at levee toe.

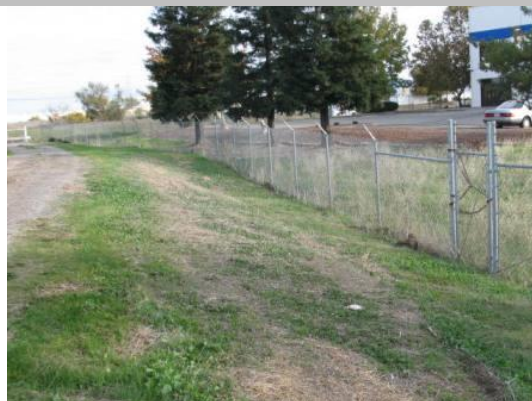
Photo 1 of 1 : SP\_2020\_NA0001\_59\_8\_20200302\_00005.jpg

LM Start	1.39	Rating **	M	Issue No.	8
LM End	1.43	Issue Type +	En	Location *	LS
Category	Earthen Levee			GPS Latitude/Longitude	
				Start	End
Item	Encroachments			38.660968 °	38.660828 °
				-121.430023 °	-121.429428 °
DWR ID	DWR_NA0001_08_s_2013_8				
Comment Code					
FE : Fence					
Inspector Comment					
Cyclone fence alignment returns to within 10' of toe.

11/17/2011 Chainlink fence alignment returns to the levee toe.

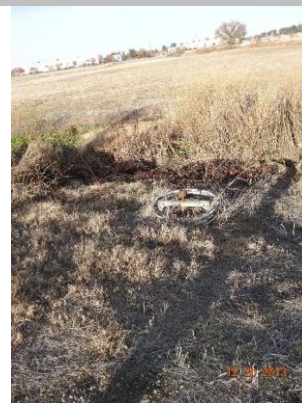
Photo 1 of 3 : UCIP\_SP\_2020\_29329\_54333.jpg

Comment Code						
Inspector Comment						
DS_ID:24384 FS_ID:29329 EP_NO: N/A Repair Type: Non-Urgent Crossing Status: Indicator Found UCIP Comments: Non-functional crossing--need to coordinate with owner, DWR-Inspector, and CVFPB to determine how to properly abandon crossing. FIELD_STRUCT_DESC: *ABANDONED* 24-inch corrugated metal (CM) pipe through the levee, 8 feet below the crown. Two CM cutoff walls around pipe. Slide gate in 30-inch CM riser and flap gate on waterside (WS) end. Concrete "U" headwall and splash apron on WS end. Landside (LS) end cutoff and plugged, riser filled with dirt. [Additional Reference(s): DWR Levee Log, 2002. USACE Sacramento O&M Manual Unit 118, Part No. 2, October 1959, Drawing No. 1-4-392 Exhibit B, (Station 72+10)] FS Date: 12/20/2013

View of riser with slide gate located on waterward side.

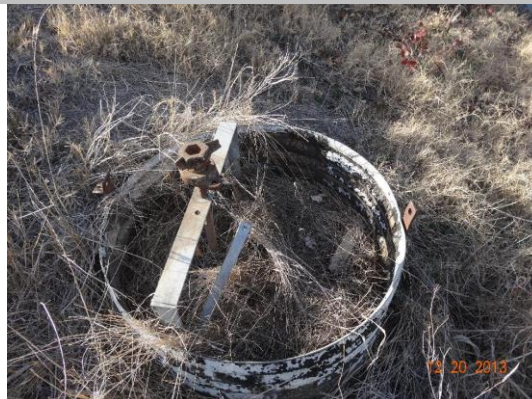
Photo 2 of 3 : UCIP\_SP\_2020\_29329\_54332.jpg

Slide gate non-functional--riser filled with soil.

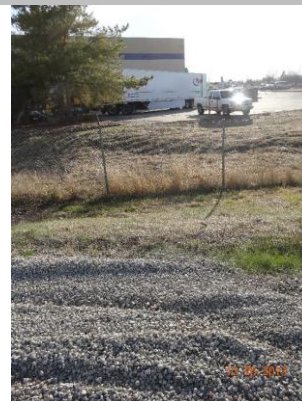
Photo 3 of 3 : UCIP\_SP\_2020\_29329\_54334.jpg

View of landward side.

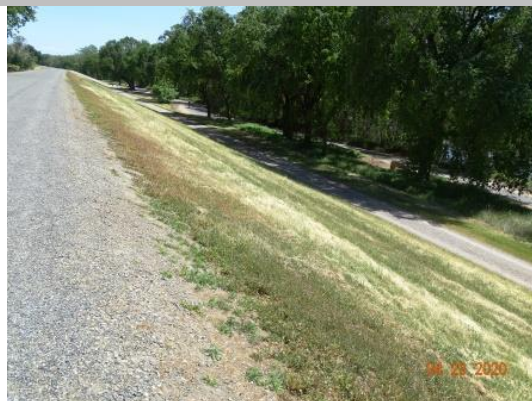
Photo 1 of 1 : SP\_2020\_NA0001\_60\_23\_20200508\_00039.jpg

LM Start	0.00	Rating **	A	Issue No.	23
LM End	4.19	Issue Type +	Ma	Location *	WS
Category	Earthen Levee			GPS Latitude/Longitude	
				Start	End
Item	Vegetation			38.567911 °	38.588999 °
				-121.383169 °	-121.428178 °
DWR ID	DWR_NA0001_09_s_2020_23				
Comment Code					
V1 : Control annual grass and weeds on the levee slopes and easements.					
Inspector Comment					
The annual waterside vegetation is well-maintained.

View of well-maintained waterside vegetation. Spring 2020

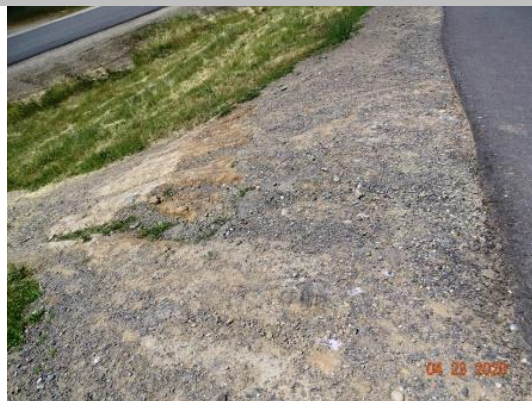
Photo 1 of 1 : SP\_2020\_NA0001\_60\_20\_20200508\_00038.jpg

LM Start	0.01	Rating **	A/W	Issue No.	20
LM End	0.01	Issue Type +	Ma	Location *	WS
Category	Earthen Levee			GPS Latitude/Longitude	
				Start	End
Item	Slope Stability			38.567953 °	38.567953 °
				-121.383343 °	-121.383343 °
DWR ID	DWR_NA0001_09_s_2019_20				
Comment Code					
S2 : Repair the levee slope damaged by foot traffic and prevent access where possible.					
Inspector Comment					
Monitor the footpath.

View of footpath on the waterside slope. Spring 2020

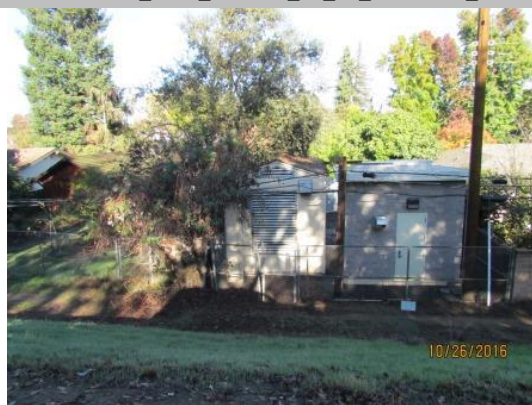
Photo 1 of 1 : SP\_2020\_NA0001\_60\_14\_20200302\_00003.jpg

LM Start	0.45	Rating **	N	Issue No.	14
LM End	0.45	Issue Type +	Ma	Location *	LS
Category	Earthen Levee			GPS Latitude/Longitude	
				Start	End
Item	Trim / Thin Trees			38.566298 °	38.566298 °
				-121.390680 °	-121.390680 °
DWR ID	DWR_NA0001_09_s_2012_14				
Comment Code					
T5 : Tree stumps.					
Inspector Comment

View of tree trunk at fence line. Fall 2016

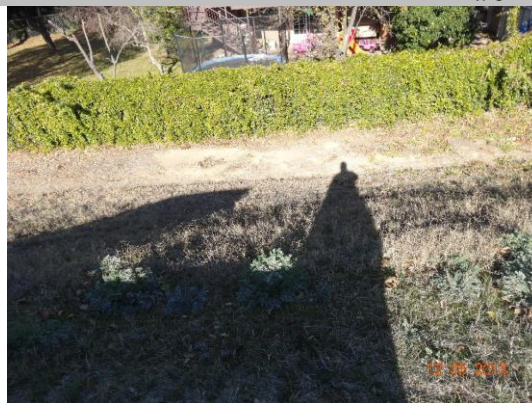
Photo 1 of 3 : UCIP\_SP\_2020\_56880\_54363.jpg

Comment Code						
Inspector Comment						
DS_ID:24394 FS_ID:56880 EP_NO: N/A Repair Type: Non-Urgent Crossing Status: Indicator Found UCIP Comments: 08/16/2017 DWR Deferred Maintenance Project (DMP), Vince Rodriguez, forwarded email received from Tim Kerr, General Manager of American River Flood Control District (ARFCD) with file "DWR Eligible Pipes Found in ARFCD" from ARFCD that shows the ownership and location of the pipes Tim Kerr investigated. No owner mentioned in email, ARFCD Staff Notes indicate riser in floodway near Beckenwood Way. (DWR UCIP - O. Magana) 12/05/2013 Need to contact owner to determine status of crossing. (DWR UCIP - O. Magana) FIELD_STRUCT_DESC: *Assumed ABANDONED* 12-inch steel pipe of an unknown purpose through the levee, 14 feet below the crown. Riser unit on the waterside (WS). (Reference to 12-inch pipe scheduled to be abandoned [no clear direction of action taken available in permit recordation, see page 14 of 27 electronic permit copy] under Permit No. 4622, 1964 - County of Sacramento). [Additional Reference(s): DWR Levee Log, 2002 (HLM 1.31). USACE Sacramento O&M Manual Unit 517, Part No. 1, November 1959, Drawing No. 1-4-415, Sheet No. 415/6, February 1957, (Station 296+85)] FS Date: 4/30/2020

View of LS levee slope.

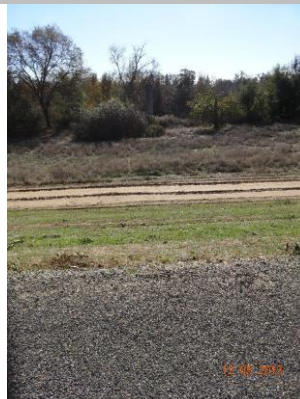
Photo 2 of 3 : UCIP\_SP\_2020\_56880\_54362.jpg

View of the floodway on the WS. Tall riser located approximately 200 feet from levee toe.

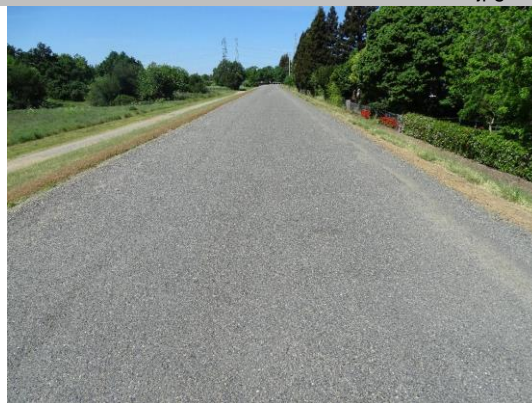
Photo 3 of 3 : UCIP\_SP\_2020\_56880\_84108.jpg

Overview of levee crown looking d/s.

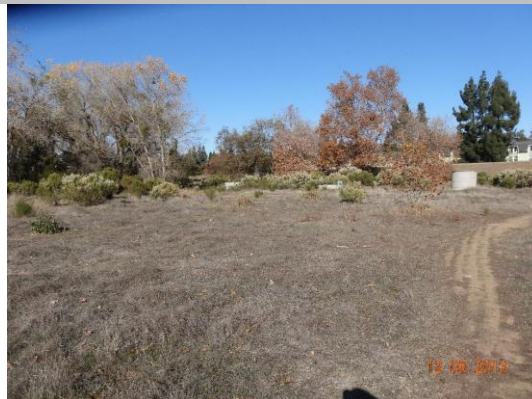
Photo 1 of 3 : UCIP\_SP\_2020\_56885\_54369.jpg

LM Start	1.93	Rating **	M	Issue No.	34
LM End	1.93	Issue Type +	En	Location *	
Category	Supplemental			GPS Latitude/Longitude	
				Start	End
Item	DWR UCIP Field Study			38.560889 °	38.560889 °
				-121.417196 °	-121.417196 °
DWR ID	24597				
Comment Code					
Inspector Comment					
DS_ID:24597 FS_ID:56885 EP_NO: 17587 Repair Type: Non-Urgent Crossing Status: Indicator Found UCIP Comments: Unable to confirm if riser belongs to this crossing--need to coordinate with owner to determine specifics. Description needs to be updated. FIELD_STRUCT_DESC: 54-inch water main of an unknown material through the levee, at an unknown depth. (54-inch pipe authorized under Permit No. 17587, 2003 - City of Sacramento). FS Date: 4/30/2020

Three risers located on the WS berm.

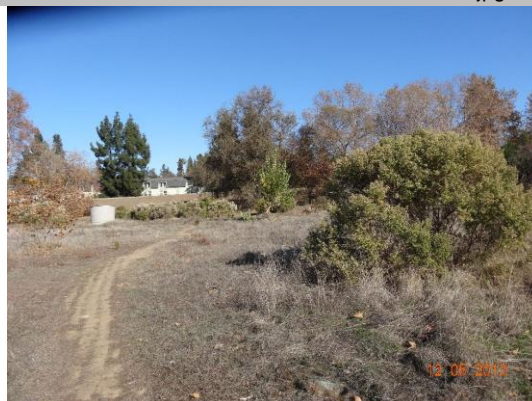
Photo 2 of 3 : UCIP\_SP\_2020\_56885\_54368.jpg

View of the WS berm looking toward levee from the riverbank.

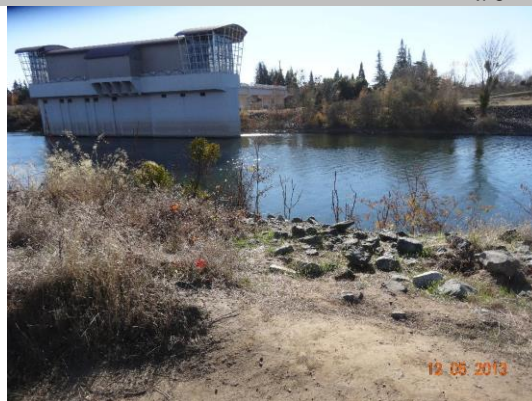
Photo 3 of 3 : UCIP\_SP\_2020\_56885\_54367.jpg

View of rip rap along the riverbank.

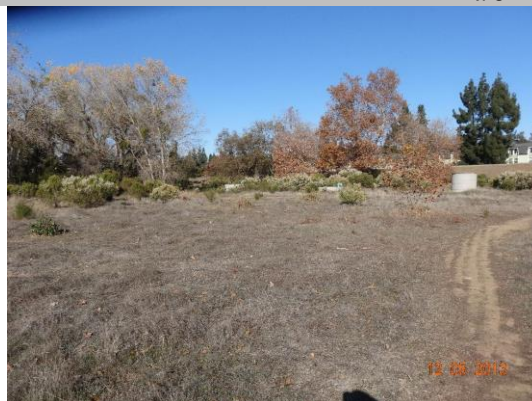
Photo 1 of 3 : UCIP\_SP\_2020\_56886\_55522.jpg

DS\_ID:24395  
 FS\_ID:56886  
 EP\_NO: N/A  
 Repair Type: Non-Urgent  
 Crossing Status: Indicator Found  
 UCIP Comments: unable to confirm crossing--need to contact owner to determine status of crossing.  
 FIELD\_STRUCT\_DESC: 60-inch steel sewer main through the American River overflow area, at an unknown depth. (Erosion protection and rock revetment on the waterside (WS) slope added under Permit No. 14487, 1986 - Sacramento County Department of Public Works). [Additional Reference(s): DWR Levee Log, 2002 (HLM 1.95)]  
 FS Date: 4/30/2020

View of WS berm and three risers looking toward the levee from the riverbank.

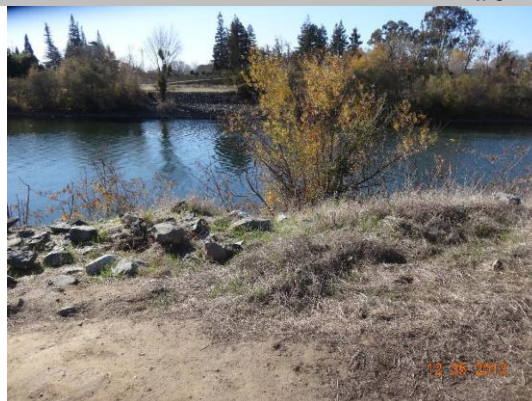
Photo 2 of 3 : UCIP\_SP\_2020\_56886\_55521.jpg

Rip rap on the WS along the riverbank.

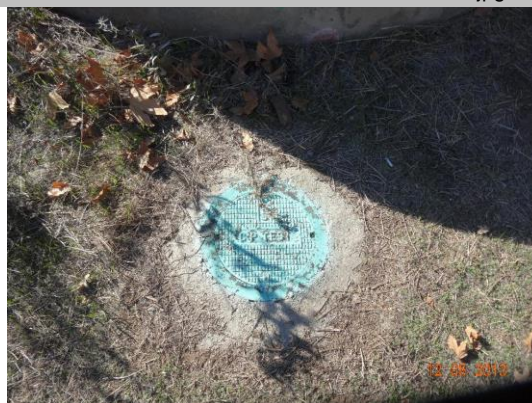
Photo 3 of 3 : UCIP\_SP\_2020\_56886\_55520.jpg

Small handhole found near concrete cylinder.

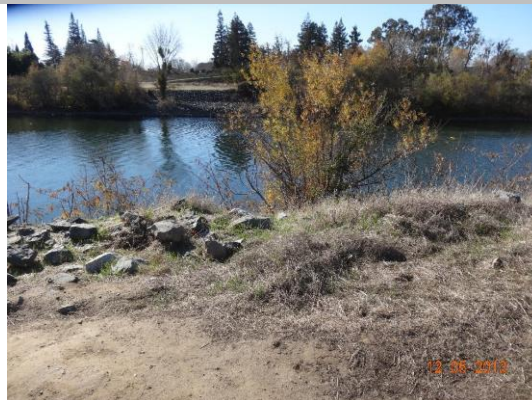
Photo 2 of 3 : UCIP\_SP\_2020\_56887\_54712.jpg

View of rip rap along the riverbank.

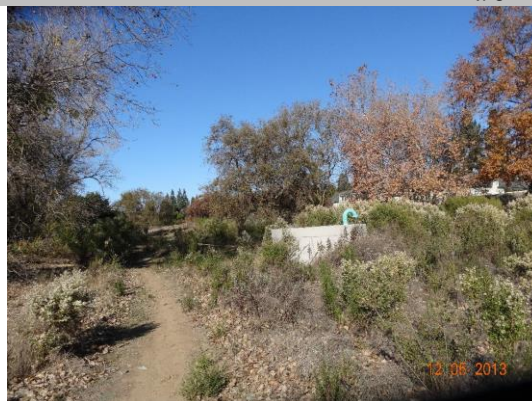
Photo 3 of 3 : UCIP\_SP\_2020\_56887\_54711.jpg

View of second concrete cylinder located on the WS berm.

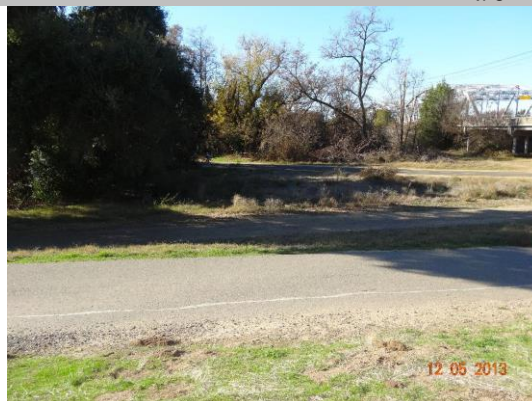
Photo 1 of 3 : UCIP\_SP\_2020\_56890\_57338.jpg

LM Start	2.51	Rating **	M	Issue No.	37
LM End	2.51	Issue Type +	En	Location *	
Category	Supplemental			GPS Latitude/Longitude	
				Start	End
Item	DWR UCIP Field Study			38.568767 °	38.568767 °
				-121.421178 °	-121.421178 °
DWR ID	24515				
Comment Code					
Inspector Comment					
DS_ID:24515 FS_ID:56890 EP_NO: N/A Repair Type: Non-Urgent Crossing Status: Indicator Found UCIP Comments: Unable to confirm crossing. will need to contact owner to determine specifics and status of crossing. FIELD_STRUCT_DESC: 36-inch corrugated metal (CM) drainage pipe through the levee, at an unknown depth. Riser unit on the waterside (WS). [Additional Reference(s): USACE Sacramento O&M Manual Unit 517, Part No. 1, November 1959, Drawing No. 1-4-415, Sheet No. 415/7, February 1957, (Station 365+14)] FS Date: 4/30/2020

View of the WS berm. "H" Street Bridge in the background.

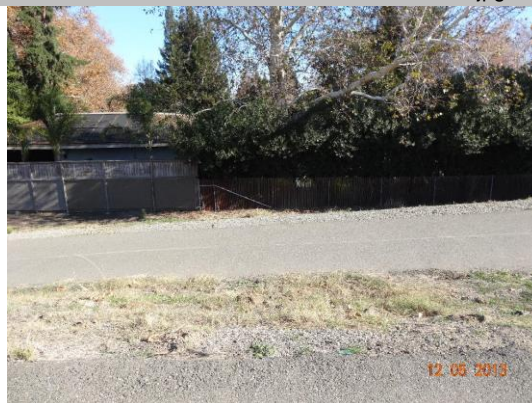
Photo 2 of 3 : UCIP\_SP\_2020\_56890\_57337.jpg

View of the LS.

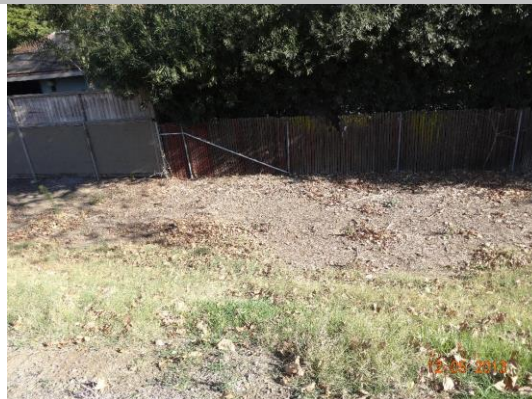
Photo 3 of 3 : UCIP\_SP\_2020\_56890\_57336.jpg

LS toe cleared of debris.

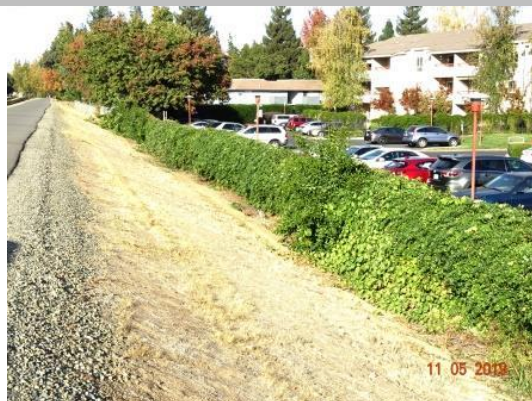
Photo 1 of 1 : SP\_2020\_NA0001\_60\_2\_20200302\_00002.jpg

LM Start	3.06	Rating **	U	Issue No.	2
LM End	3.19	Issue Type +	En	Location *	LS
Category	Earthen Levee			GPS Latitude/Longitude	
				Start	End
Item	Encroachments			38.576423 °	38.578248 °
				-121.419117 °	-121.418475 °
DWR ID	DWR_NA0001_09_s_2012_2				
Comment Code					
FE : Fence					
Inspector Comment					
Vegetation on the fence blocks visibility.

View of vegetation on chainlink fence that obstructs visibility. Fall 2019

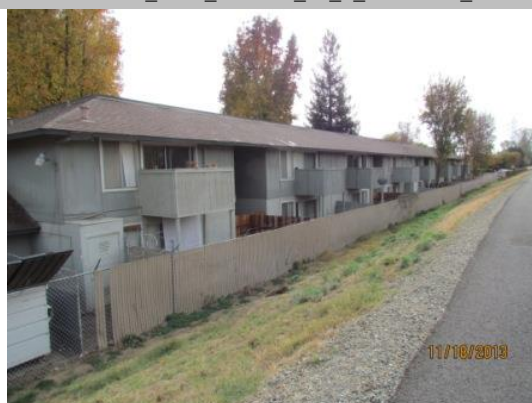
Photo 1 of 1 : SP\_2020\_NA0001\_60\_1\_20200302\_00001.jpg

LM Start	3.19	Rating **	U	Issue No.	1
LM End	3.27	Issue Type +	En	Location *	LS
Category	Earthen Levee			GPS Latitude/Longitude	
				Start	End
Item	Encroachments			38.578258 °	38.579363 °
				-121.418475 °	-121.418100 °
DWR ID	DWR_NA0001_09_s_2012_1				
Comment Code					
FE : Fence					
Inspector Comment

View of the fence at the landside levee toe. Fall 2013

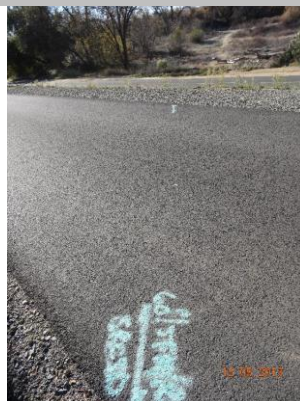
Photo 1 of 3 : UCIP\_SP\_2020\_56902\_55526.jpg

LM Start	3.32	Rating **	M	Issue No.	38
LM End	3.32	Issue Type +	En	Location *	
Category	Supplemental			GPS Latitude/Longitude	
				Start	End
Item	DWR UCIP Field Study			38.580094 °	38.580094 °
				-121.417821 °	-121.417821 °
DWR ID	24412				
Comment Code					
Inspector Comment					
DS_ID:24412 FS_ID:56902 EP_NO: 17671 Repair Type: Non-Urgent Crossing Status: Indicator Found UCIP Comments: unable to confirm if manhole is part of this crossing-- need to contact owner to determine status of crossing. FIELD_STRUCT_DESC: 1 of 2: 60-inch steel sewer force main underneath the levee, at an unknown depth. Connects to a 60-inch main line on the landside (LS). (Two 60-inch force mains authorized under Permit No. 17671, 2003 - Sacramento Regional County Sanitation District). FS Date: 5/1/2020

View of levee crown and WS berm. USA markings in pavement.

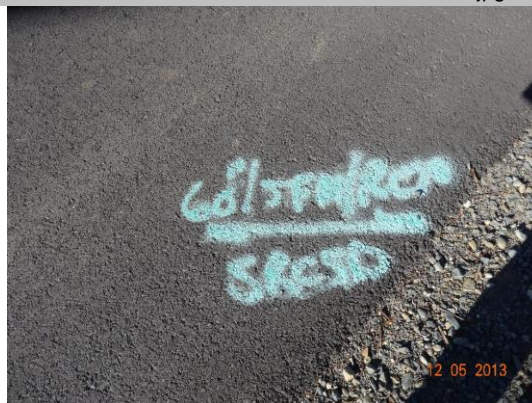
Photo 2 of 3 : UCIP\_SP\_2020\_56902\_55528.jpg

View of levee crown. USA markings in pavement.

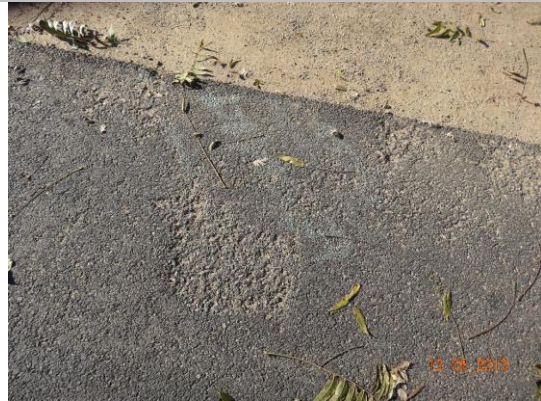
Photo 2 of 3 : UCIP\_SP\_2020\_56903\_54790.jpg

DS\_ID:24404  
FS\_ID:56903  
EP\_NO: 12188  
Repair Type: Non-Urgent  
Crossing Status: Indicator Found  
UCIP Comments: unable to confirm if crossing is still active--need to contact owner to determine status of crossing.  
FIELD\_STRUCT\_DESC: 60-inch concrete encased steel sewer force main through the levee, 17.0 feet below the crown. Cutoff wall around the pipe at the center of the levee. Rock revetment on the waterside (WS) slope. Three pressure manholes in the overflow area along the bike path. (60-inch force main authorized under Permit No. 12188, 1979 - Sacramento Regional County Sanitation District). [Additional Reference(s): DWR Levee Log, 2002 (HLM 3.50)]  
FS Date: 5/1/2020

USA markings on the levee crown.

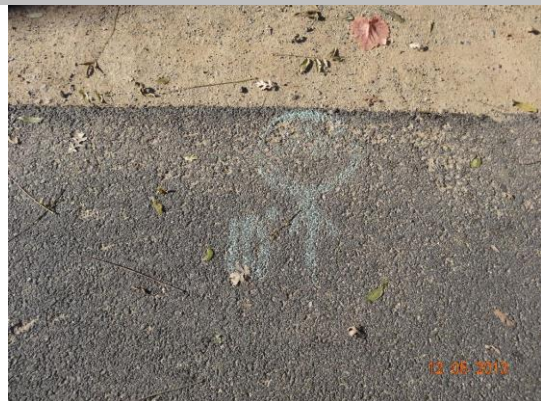
Photo 3 of 3 : UCIP\_SP\_2020\_56903\_54789.jpg

USA markings on the levee crown.

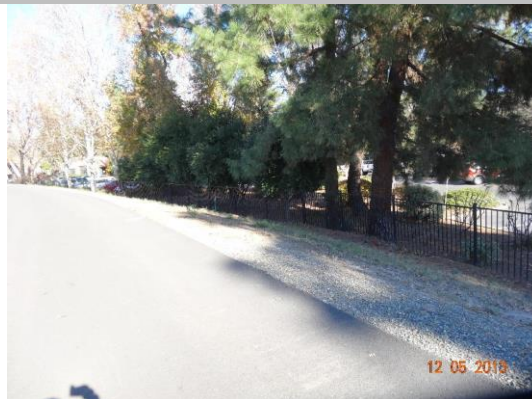
Photo 1 of 3 : UCIP\_SP\_2020\_56904\_55532.jpg

LM Start	3.34	Rating **	M	Issue No.	40	
LM End	3.34	Issue Type +	En	Location *		
Category	Supplemental			GPS Latitude/Longitude		
				Start	End	
Item	DWR UCIP Field Study			38.580435 °	38.580435 °	
				-121.417711 °	-121.417711 °	
DWR ID	24566					
Comment Code						
Inspector Comment						
DS_ID:24566 FS_ID:56904 EP_NO: 17671 Repair Type: Non-Urgent Crossing Status: Indicator Found UCIP Comments: Need to confirm location with owner. FIELD_STRUCT_DESC: 2 of 2: 60-inch sewer force main of an unknown material underneath the levee, at an unknown depth. Connects to a 60-inch main on the landside (LS). (Two 60-inch force mains authorized under Permit No. 17671, 2003 - Sacramento Regional County Sanitation District). FS Date: 5/1/2020

Overview of LS levee slope looking d/s.

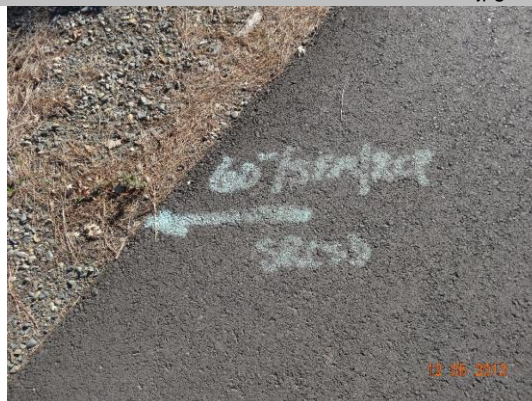
Photo 2 of 3 : UCIP\_SP\_2020\_56904\_55531.jpg

USA markings found on the levee crown for a 60-inch pipe.

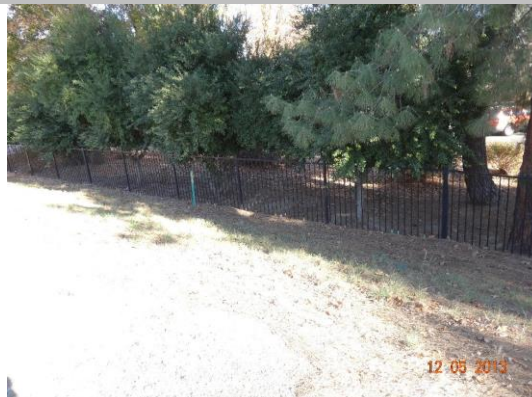
Photo 3 of 3 : UCIP\_SP\_2020\_56904\_55530.jpg

Marker for sewer line visible just off the LS toe in front of metal fence.

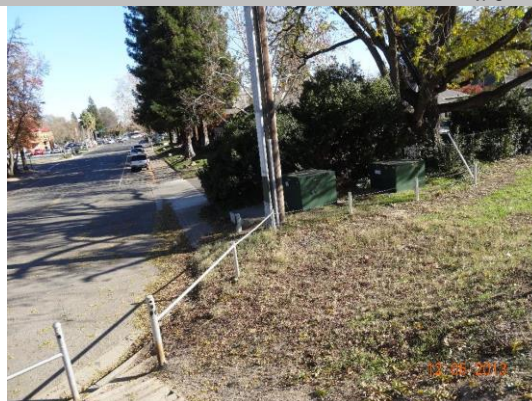
Photo 1 of 3 : UCIP\_SP\_2020\_56905\_56473.jpg

DS\_ID:24816  
 FS\_ID:56905  
 EP\_NO: N/A  
 Repair Type: Non-Urgent  
 Crossing Status: Indicator Found  
 UCIP Comments: unable to determine if crossing goes through levee.  
 Need to obtain additional information to confirm crossing.  
 FIELD\_STRUCT\_DESC: Water fountain found on the waterside (WS).  
 FS Date: 5/1/2020

View of the LS.

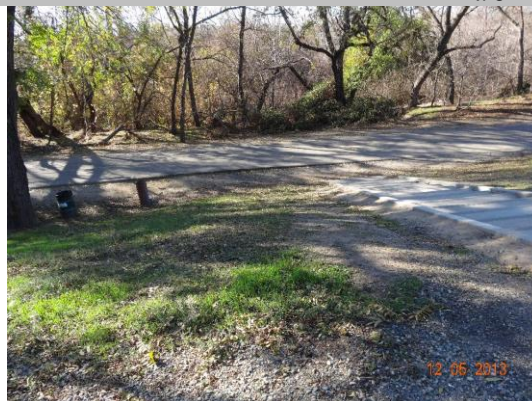
Photo 2 of 3 : UCIP\_SP\_2020\_56905\_56472.jpg

View of WS slope and berm. Drinking fountain located at the WS levee toe.

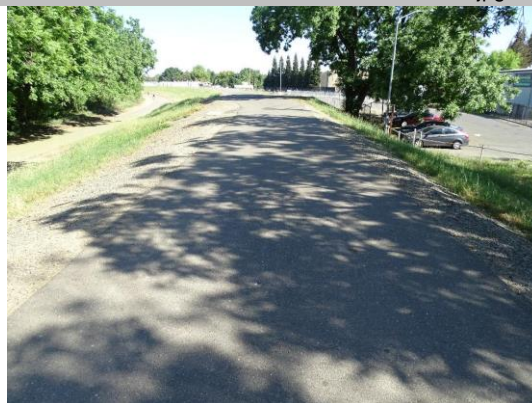
Photo 3 of 3 : UCIP\_SP\_2020\_56905\_84222.jpg

Overview of levee crown looking d/s.

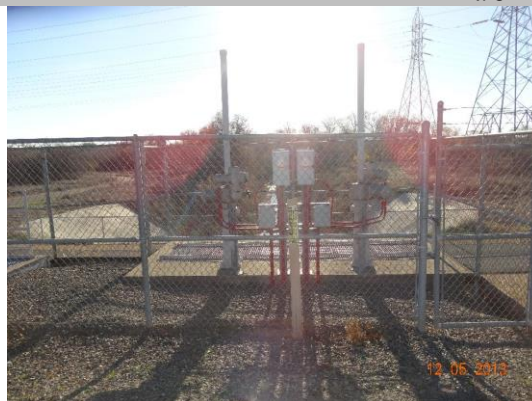
Photo 1 of 3 : UCIP\_SP\_2020\_56907\_57325.jpg

DS\_ID:24817  
FS\_ID:56907  
EP\_NO: N/A  
Repair Type: Non-Urgent  
Crossing Status: Found  
UCIP Comments: 08/16/2017 DWR Deferred Maintenance Project (DMP), Vince Rodriguez, forwarded email received from Tim Kerr, General Manager of American River Flood Control District (ARFCD) with file "DWR Eligible Pipes Found in ARFCD" from ARFCD that shows the ownership and location of the pipes Tim Kerr investigated. Owner of this crossing is identified as the County of Sacramento, ARFCD Staff Notes indicate D-05 Upstream end of detention basin. (DWR UCIP - O. Magana)  
12/05/2013 Need to confirm crossing size--need additional information about crossing. (DWR UCIP - O. Magana)  
FIELD\_STRUCT\_DESC: 1 of 2: Drainage pipe of an unknown size or material through the levee, at an unknown depth. 7-foot by 15-foot concrete structure located on the waterside (WS) shoulder with a slide gate inside a manhole. Square flap gate located on the WS end. Concrete wings and apron at the WS end of the outlet channel. Concrete box located on the WS shoulder (fenced off). No permit has been identified authorizing this structure. Structure is owned by the County of Sacramento.

Concrete box, electrical box, and screw gates located on the WS shoulder.

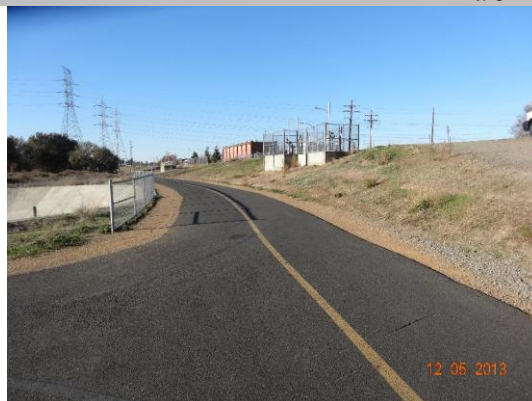
Photo 2 of 3 : UCIP\_SP\_2020\_56907\_57320.jpg

Bike path located on the WS between the screw gates and the outlet structure.

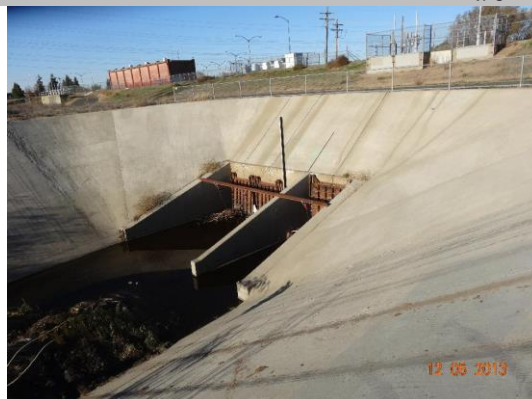
Photo 3 of 3 : UCIP\_SP\_2020\_56907\_57324.jpg

View of the outlet structure and drainage channel located 20 feet off the WS levee toe.

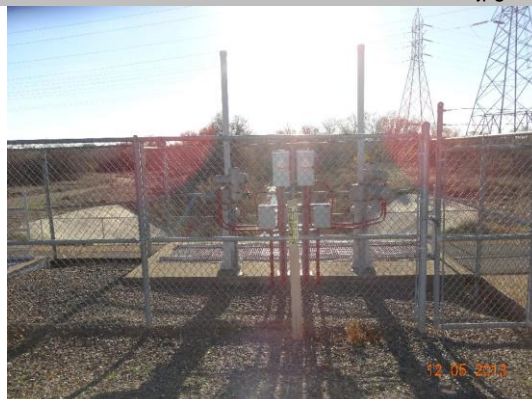
Photo 1 of 3 : UCIP\_SP\_2020\_56909\_57333.jpg

DS\_ID:24818  
 FS\_ID:56909  
 EP\_NO: N/A  
 Repair Type: Non-Urgent  
 Crossing Status: Found  
 UCIP Comments: 08/16/2017 DWR Deferred Maintenance Project (DMP), Vince Rodriguez, forwarded email received from Tim Kerr, General Manager of American River Flood Control District (ARFCD) with file "DWR Eligible Pipes Found in ARFCD" from ARFCD that shows the ownership and location of the pipes Tim Kerr investigated. Owner of this crossing is identified as the County of Sacramento, ARFCD Staff Notes indicate D-05 Upstream end of detention basin. (DWR UCIP - O. Magana)  
 12/05/2013 Unable to confirm pipe size--need additional information about crossing. (DWR UCIP - O. Magana)  
 FIELD\_STRUCT\_DESC: 2 of 2: Crossing through the levee at an unknown depth. 7-foot by 15-foot concrete structure located on the waterside (WS) shoulder with a slide gate inside a manhole. Square flap gate located on the WS end. Concrete wings and apron at the WS end of the outlet channel. Concrete box located on the WS shoulder (fenced off). No permit has been identified authorizing this structure. Structure is owned by the County of Sacramento.

Concrete box and electrical boxes located on the WS shoulder.

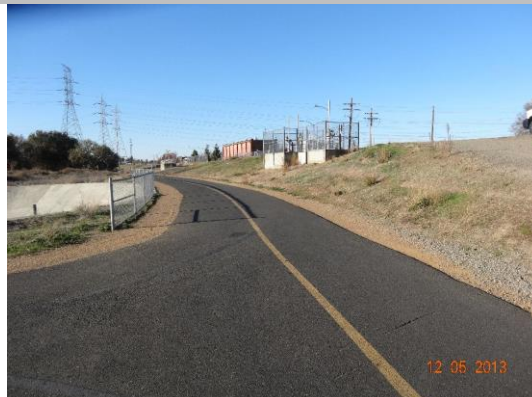
Photo 2 of 3 : UCIP\_SP\_2020\_56909\_57328.jpg

Bike path located on the WS between the screw gates and the outlet structure.

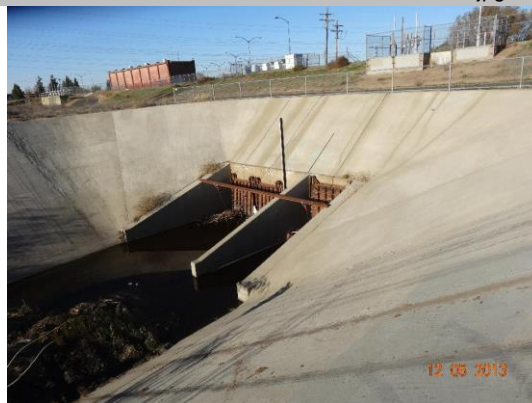
Photo 3 of 3 : UCIP\_SP\_2020\_56909\_57332.jpg

View of the outlet structure and drainage channel located 20 feet off the WS levee toe.

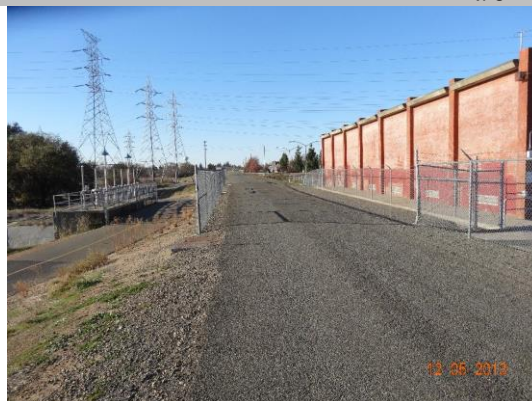
Photo 1 of 2 : UCIP\_SP\_2020\_56910\_57335.jpg

DS\_ID:24819  
FS\_ID:56910  
EP\_NO: N/A  
Repair Type: Non-Urgent  
Crossing Status: Found  
UCIP Comments: Unable to confirm is pipe crosses levee--no permit available.  
FIELD\_STRUCT\_DESC: Service box located on the waterside (WS) and the landside (LS). Unable to confirm if crossing exists through the levee. No permit was found for this potential crossing.  
FS Date: 5/1/2020

View of concrete service box located on the WS shoulder.

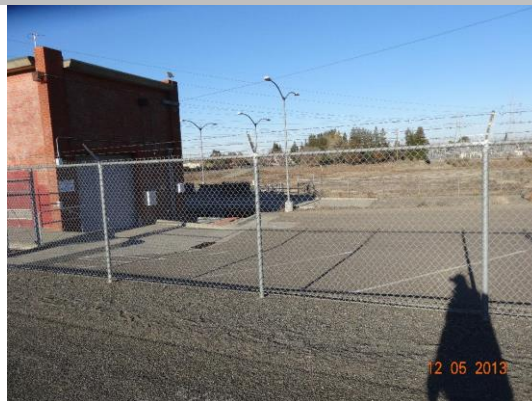
Photo 2 of 2 : UCIP\_SP\_2020\_56910\_57334.jpg

Concrete box located inside fenced area on the LS.

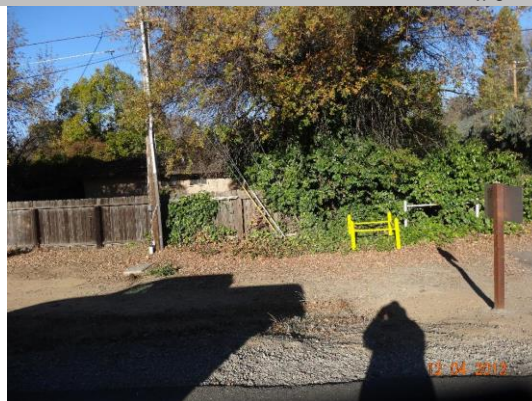
Photo 1 of 3 : UCIP\_SP\_2020\_56447\_57501.jpg

DS\_ID:24820  
FS\_ID:56447  
EP\_NO: N/A  
Repair Type: Non-Urgent  
Crossing Status: Indicator Found  
UCIP Comments: 05/13/2019 Natural gas pipeline appears to cross the levee; however, no permit has been identified for this crossing. Record evaluation remains Non-Urgent. Owner will need to obtain permit from CVFPB. (A. McDonald - DWR UCIP)08/11/2017 PG&E records for this distribution main indicate that there were no leaks found on the 05-2015 leak survey and the pipeline is operating correctly according to the 12/2016 CP inspection. (A. McDonald - DWR UCIP)12/04/2013 Unable to determine alignment of the natural gas pipeline. Does it cross the levee? Is there an encroachment permit for it?  
FIELD\_STRUCT\_DESC: Natural gas pipeline of an unknown size or material, at an unknown depth. Four bollards located on the landside (LS), about 5 feet from the LS toe, for what appears to be a natural gas pipeline. Pipeline goes through the levee and runs parallel to it. No permit found. In case of an emergency related to this pipeline, PG&E has identified the following contacts: PG&E's local pipeline engineer, Mike Aronoff, 916-307-9472 (cell) and Gas Control (north), 800-442-4743. For non-emergency issues, contact the local PG&E Gas Pipeline Operations and Maintenance (GPOM) supervisors for the Sacramento region, David Wade, 209-639-1039 (cell) or Ron Hicks, 916-396-9038 (cell).

View of protective posts located on the LS.

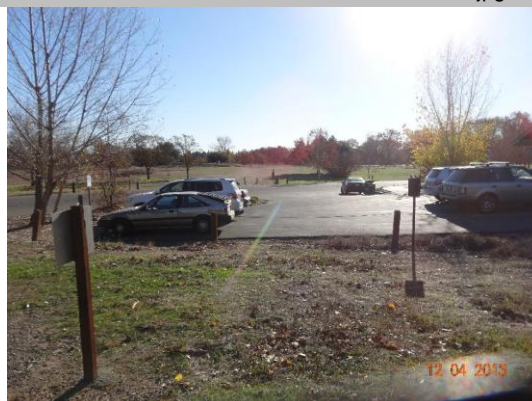
Photo 2 of 3 : UCIP\_SP\_2020\_56447\_57500.jpg

No signs of crossing on the WS.

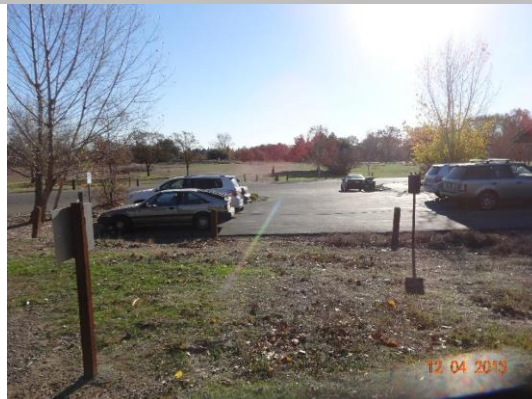
Photo 2 of 3 : UCIP\_SP\_2020\_56448\_47432.jpg

View of WS.

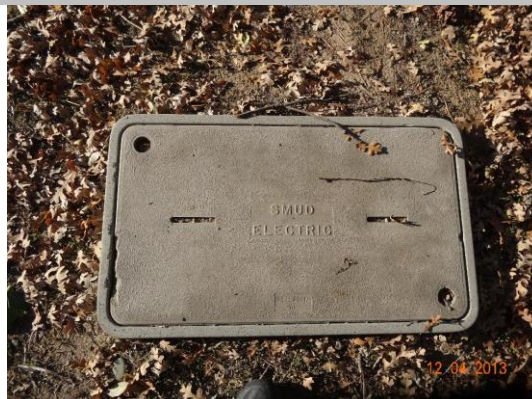
Photo 3 of 3 : UCIP\_SP\_2020\_56448\_47434.jpg

Electrical box located just off the LS toe, next to power pole.

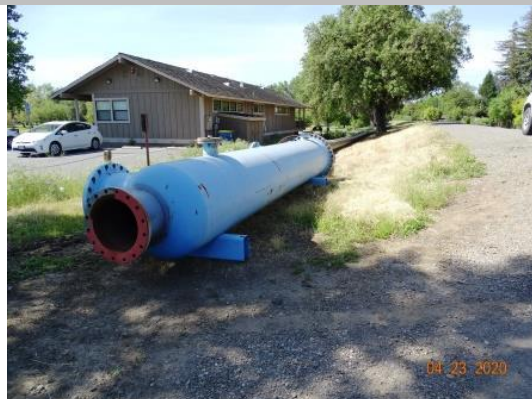
Photo 1 of 1 : SP\_2020\_NA0001\_61\_32\_20200508\_00036.jpg

LM Start	0.63	Rating **	U	Issue No.	32
LM End	0.63	Issue Type +	En	Location *	WS
Category	Earthen Levee			GPS Latitude/Longitude	
				Start	End
Item	Encroachments			38.591997 °	38.591997 °
				-121.334450 °	-121.334450 °
DWR ID	DWR_NA0001_10_s_2020_32				
Comment Code					
EQ : Equipment					
Inspector Comment					
Under Enforcement Case 15556, the Board issued NTC2018-171 for unauthorized construction.

View of equipment on the waterside toe. Spring 2020

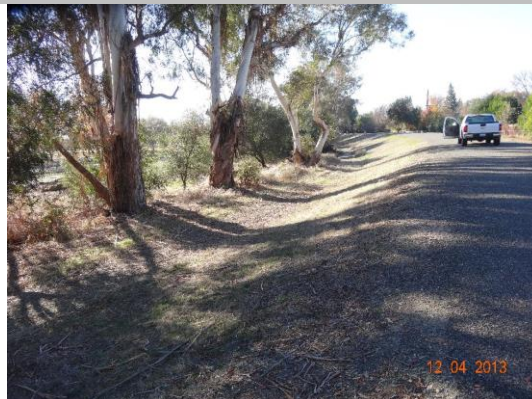
Photo 1 of 3 : UCIP\_SP\_2020\_56449\_47492.jpg

Comment Code						
Inspector Comment						
DS_ID:24464 FS_ID:56449 EP_NO: 12725 Repair Type: Non-Urgent Crossing Status: Indicator Found UCIP Comments: 05/13/2019 Permit indicates that there is a water pipe here; however, the well that used to be on the LS is now gone. Only a fence and concrete pad remain. (A. McDonald - DWR UCIP)12/04/2013 Unable to confirm if this crossing is the same under permit 12725. Drinking fountain and water flow prevention located on waterward side. Need to coordinate with American River Flood Control District. (O. Magana - DWR UCIP) FIELD_STRUCT_DESC: 6-inch steel water pipe through the levee, 2.5 feet below the crown. Arcade Water District well at the landside (LS) toe. Well is gone (2019): Just a concrete pad, a fence, and a Christy box remain. Water valves, a hitchrack, and a drinking trough for horses are on the waterside (WS). (6-inch water pipe authorized under Permit No. 12725, 1980 - County of Sacramento Department of Parks and Recreation). FS Date: 5/13/2019

Overview of WS levee slope looking d/s.

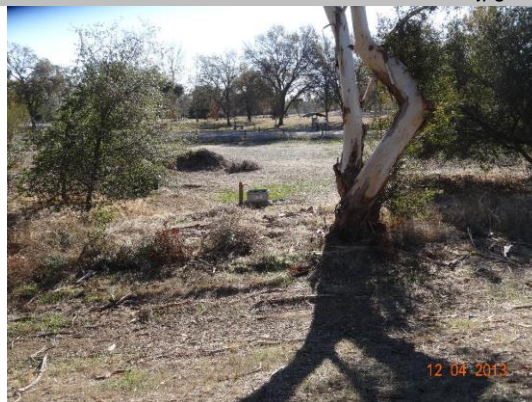
Photo 2 of 3 : UCIP\_SP\_2020\_56449\_47493.jpg

View of spigot and horse trough 20 feet off the WS toe.

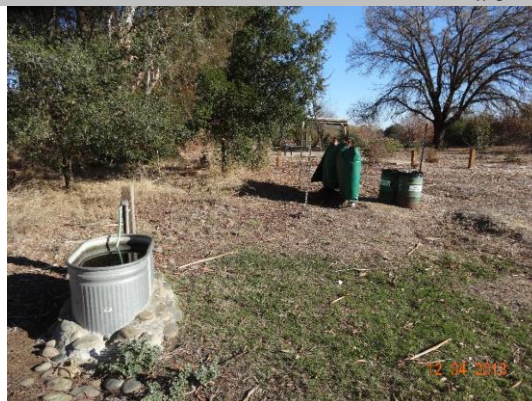
Photo 3 of 3 : UCIP\_SP\_2020\_56449\_47491.jpg

View of WS spigot and water flow prevention system.

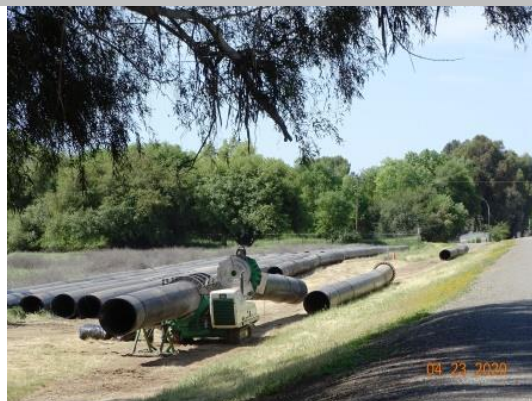
Photo 1 of 1 : SP\_2020\_NA0001\_61\_33\_20200508\_00037.jpg

LM Start	0.97	Rating **	U	Issue No.	33
LM End	0.97	Issue Type +	En	Location *	LS
Category	Earthen Levee			GPS Latitude/Longitude	
				Start	End
Item	Encroachments			38.587612 °	38.587612 °
				-121.337018 °	-121.337018 °
DWR ID	DWR_NA0001_10_s_2020_33				
Comment Code					
EQ : Equipment					
Inspector Comment					
Under Enforcement Case 15556, the Board issued NTC2018-171 for unauthorized construction.

View of pipes and equipment on the waterside toe. Spring 2020

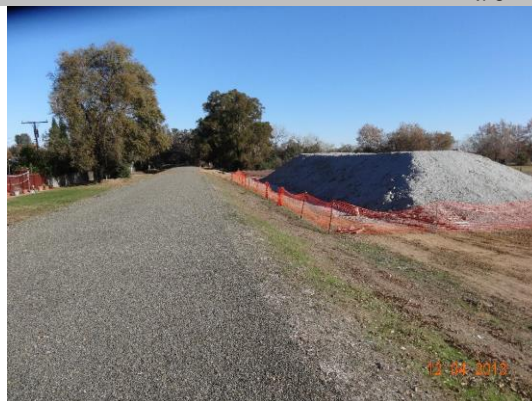
Photo 1 of 3 : UCIP\_SP\_2020\_56451\_57285.jpg

Comment Code						
Inspector Comment						
DS_ID:24821 FS_ID:56451 EP_NO: N/A Repair Type: Non-Urgent Crossing Status: Indicator Found UCIP Comments: 05/13/2019 Field discovered. No permit. Conduit box on the WS. Unable to determine if this is a crossing. Evaluated as Non-Urgent because this appears to be an unauthorized encroachment, and we cannot determine the alignment of the pipe. (A. McDonald - DWR UCIP)12/04/2013 Unable to determine reason for box and whether there is a utility that crosses levee. No permit found. (O. Magana - DWR UCIP) FIELD_STRUCT_DESC: Concrete vault on the waterside (WS), approximately 20 feet from the WS toe. Purpose unknown. FS Date: 5/13/2019

Overview of levee crown looking u/s.

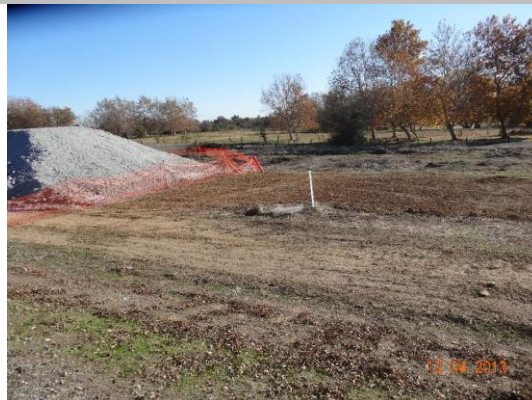
Photo 2 of 3 : UCIP\_SP\_2020\_56451\_57286.jpg

Concrete vault located on the (WS), approximately 20 feet from the toe.

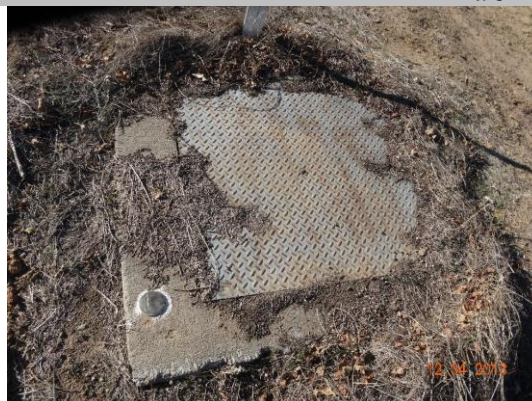
Photo 3 of 3 : UCIP\_SP\_2020\_56451\_57288.jpg

Close-up photo of concrete box located on the WS.
